Environmental Effects Report

Proposed redevelopment of the University of Georgia Legion Pool Complex

(Legion Field, Legion Pool #2604, and Bathhouse/Pavilion #2605)

802 S. Lumpkin Street, Athens, Clarke County, Georgia

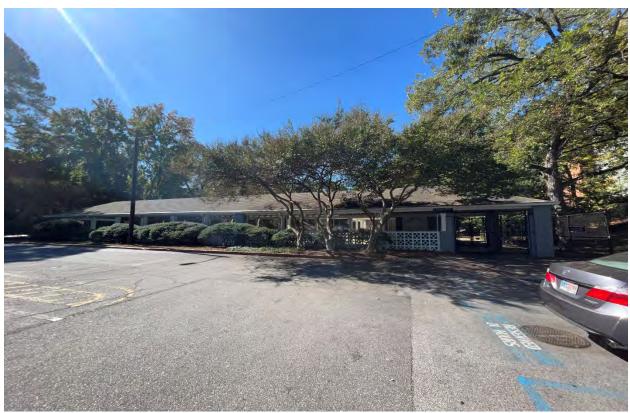
Plate 1: View – Southwest. The subject property is comprised of the Legion Pool and field, Bathhouse, and Pavilion within a portion of a parcel approximately 14.08-acres located at 802 South Lumpkin Street in Athens, Clarke County,

The UGA Legion Pool project site is located at 802 South Lumpkin Street in Clarke County, Georgia (Plates 1-3). The project site currently consists of the UGA Legion Field and Pool which is within the project site's boundaries. The subject property is adjoined to the north by Black-Diallo-Miller Hall across East Cloverhurst Avenue (Plate 4). The subject property is adjoined to the west by Legion Field (Plate 5). The subject property is adjoined to the south by multiple student dormitories (Plate 6). The subject property is adjoined to the east by the Legion Parking Lot (Plates 7). The approximate subject property boundaries and the immediate surrounding properties are shown on Figure 3.

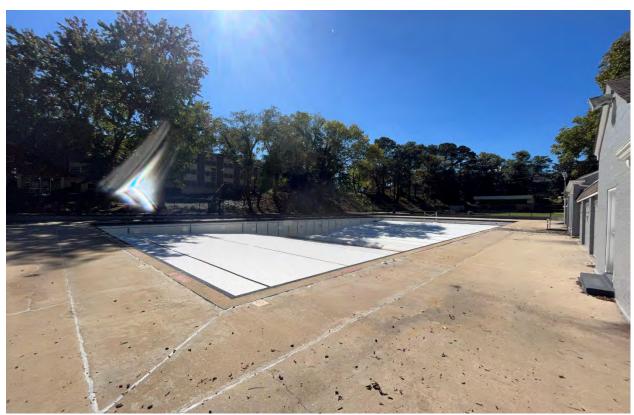
Plate 3: View – South. The subject property is comprised of the Legion Pool, Bathhouse, and Pavilion within a portion of a parcel approximately 14.08-acres located at 802 South Lumpkin Street in Athens, Clarke County, Georgia.

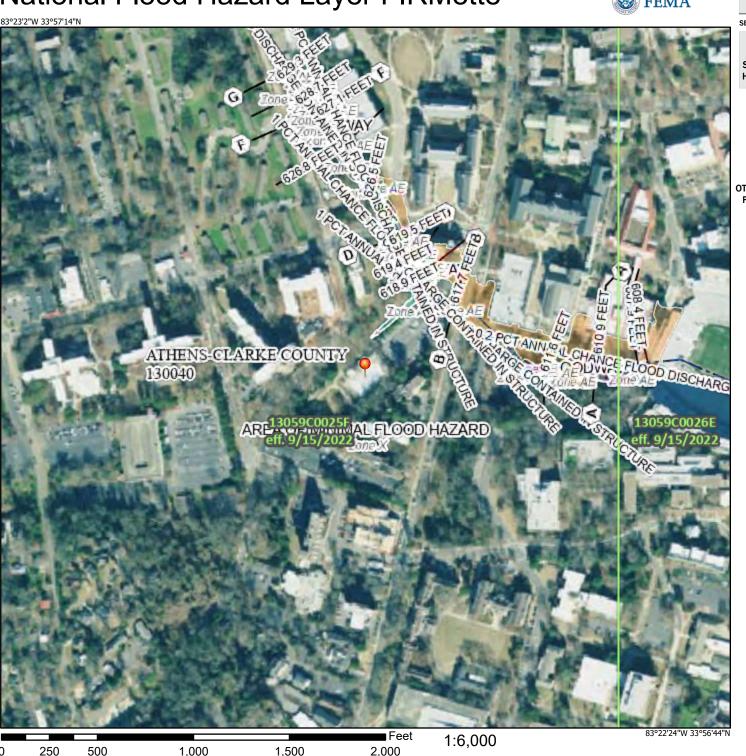
National Flood Hazard Layer FIRMette

The flood hazard information is derived directly from the authoritative NFHL web services provided by FEMA. This map was exported on 10/14/2025 at 1:38 PM and does not reflect changes or amendments subsequent to this date and time. The NFHL and effective information may change or become superseded by new data over time.

Based on a review of the Federal Emergency Management Administration (FEMA) Flood Rate Insurance Map (FIRM) for the city of Athens, Georgia, Map Number 13059C0025F (September 15, 2022) the project site is not within a special flood hazard area or flood plain. A copy of the FIRM Map showing the project site is included in the Appendix.

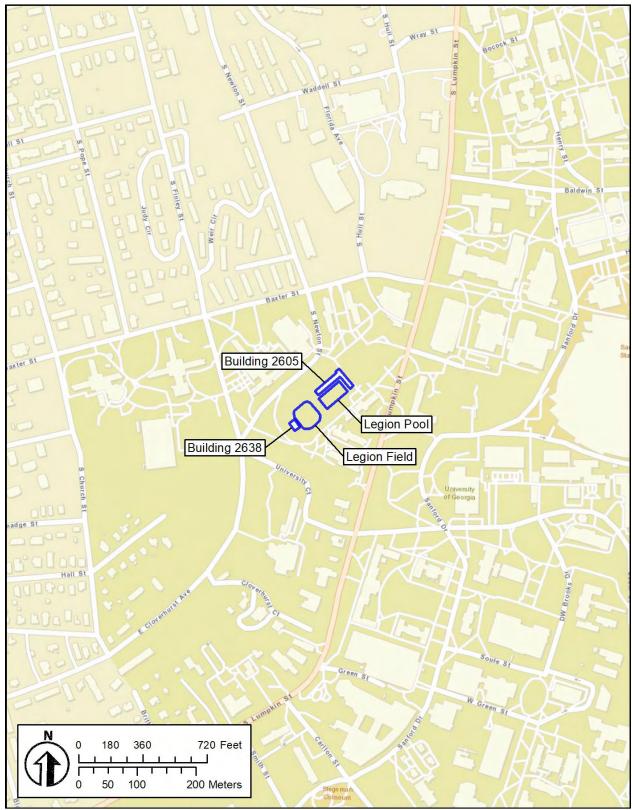
Figure 1.1 Location of Legion Pool and associated buildings.

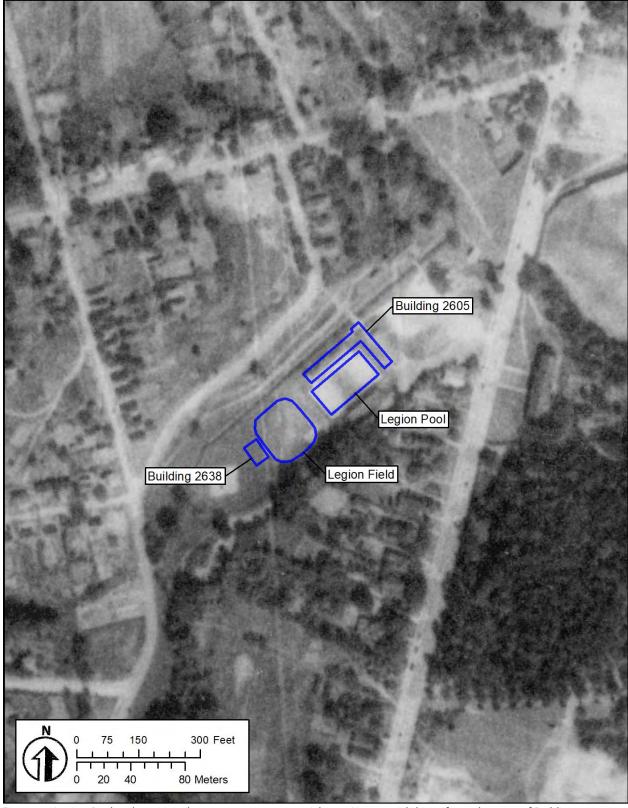
Figure 1.2 Legion Pool and associated resources on a 1938 aerial map. Note: aerial shows future location of Building 2638.

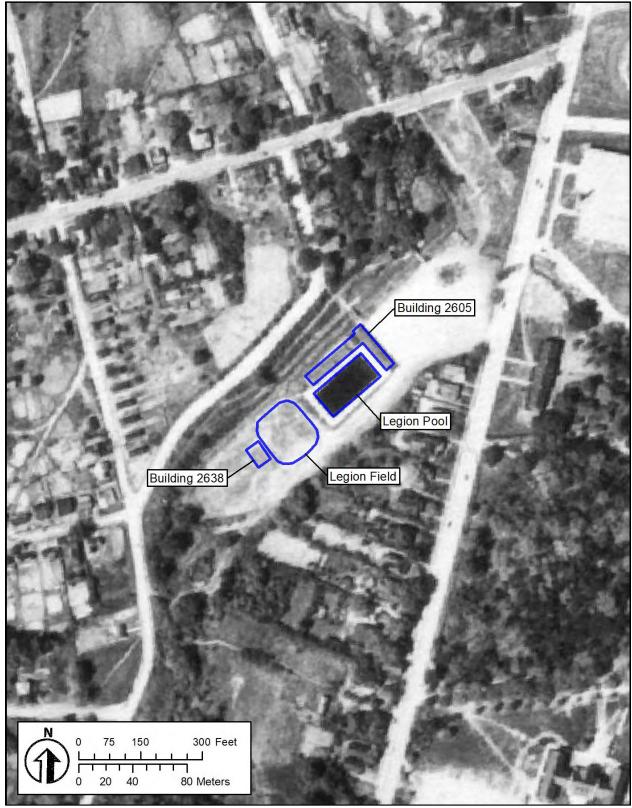
Figure 1.3 Legion Pool and associated resources on a 1944 aerial map. Note: aerial shows future location of Building 2638.

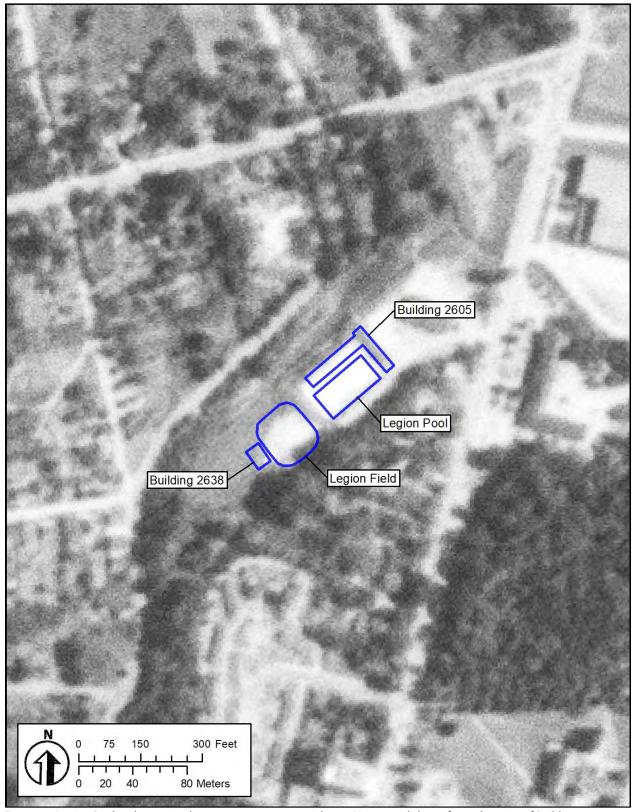
Figure 1.4 Legion Pool and associated resources on a 1951 aerial map. Note: aerial shows future location of Building 2638.

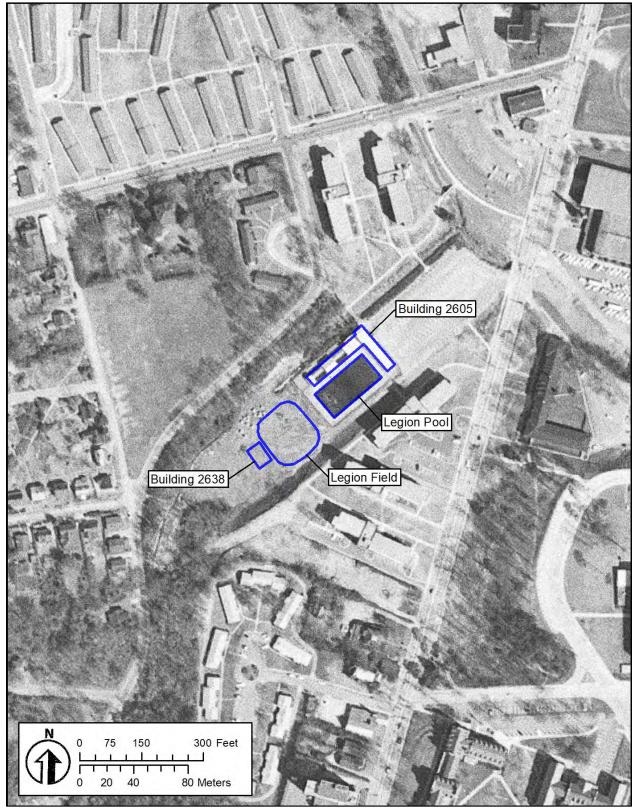
Figure 1.5 Legion Pool and associated resources on a 1962 aerial map. Note: aerial shows future location of Building 2638. Also, by this time, the old Legion log cabin, northeast of the bathhouse, had been demolished.

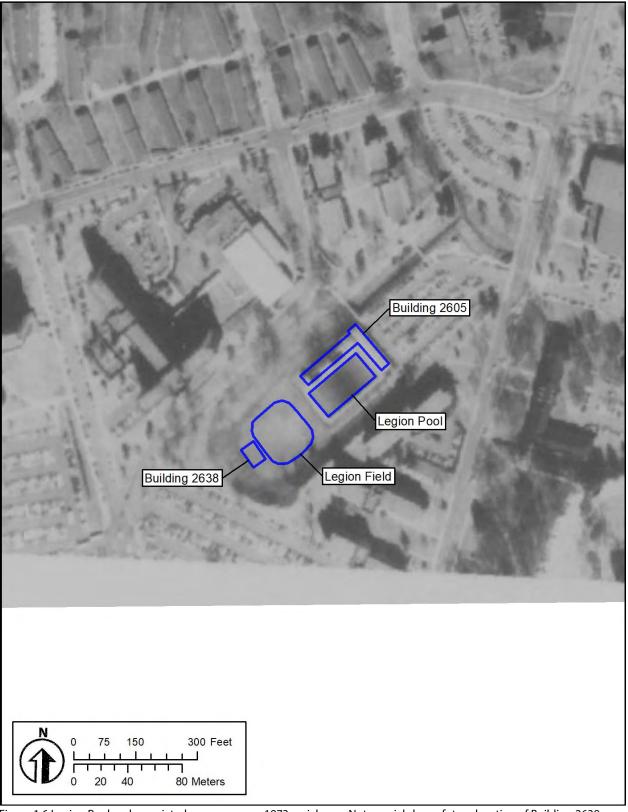
Figure 1.6 Legion Pool and associated resources on a 1973 aerial map. Note: aerial shows future location of Building 2638.

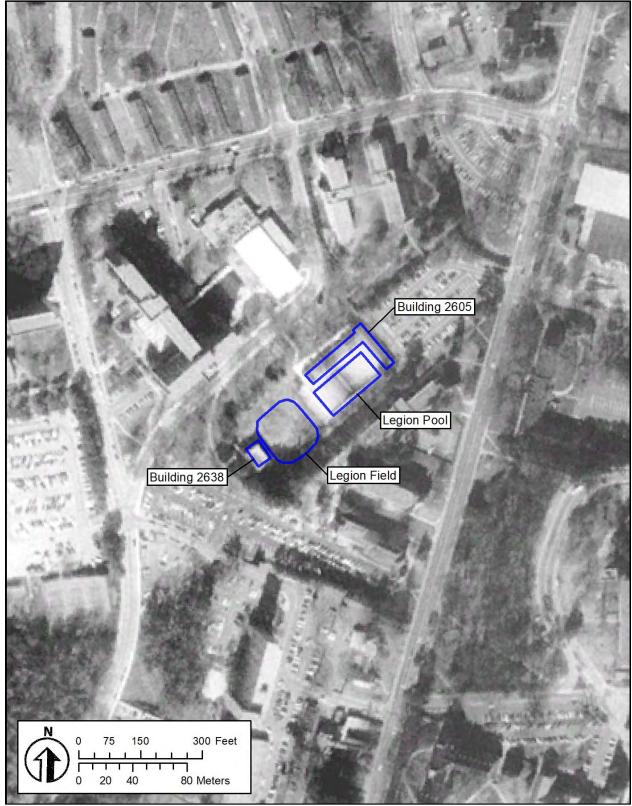
Figure 1.7 Legion Pool and associated resources on a 1993 aerial map.

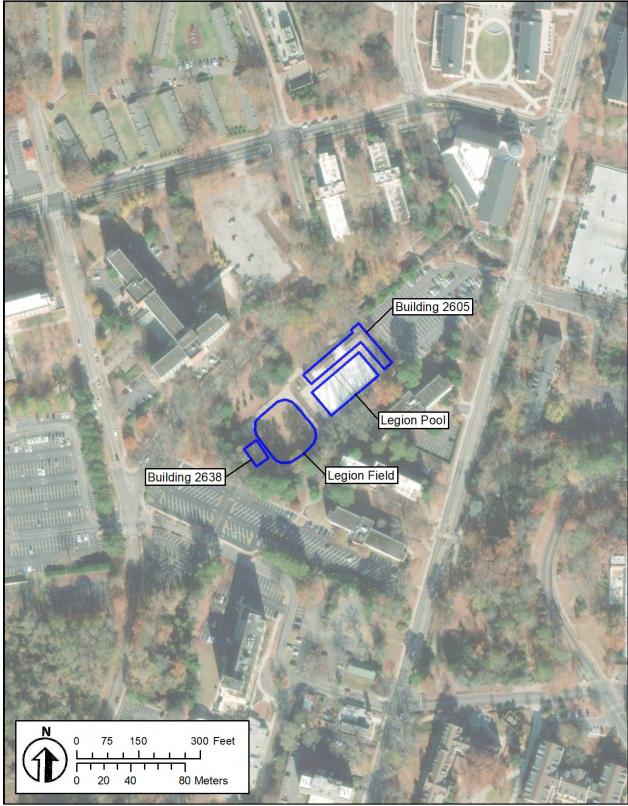
Figure 1.8 Legion Pool and associated resources on a 2025 aerial map.

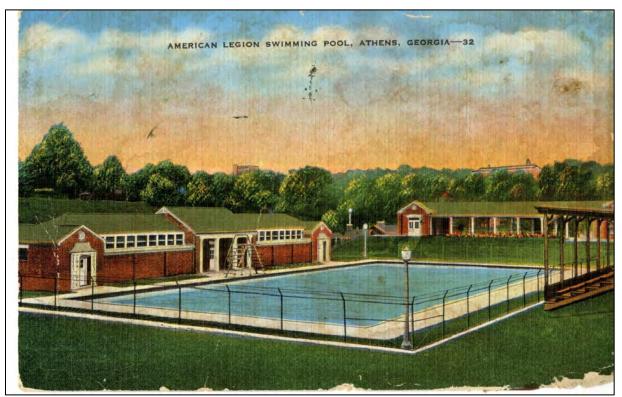
Figure 2.1 Postcard view of Legion Pool, undated. However, the pavilion design does not align with the 1942 photograph in Figure 2.2 (provided by UGA Office of Architects).

Historic photographs (Figures 2.1 through 2.3) show the bathhouse largely retaining the same footprint as today, except it was unpainted and the roofs above the showers and toilets had a raised gable with open sides, likely for ventilation. Windows were wood-framed 12-light units, and the far end wings featured doors caped with flared covers and latticework-type supports. Historic aerials suggest the original construction included a grandstand on the southeast side of the field, but these were demolished by the 1940s. The pavilion on the east side of the pool appears to have been detached from the main bathhouse, although there appears to be a covered entry area between the two.

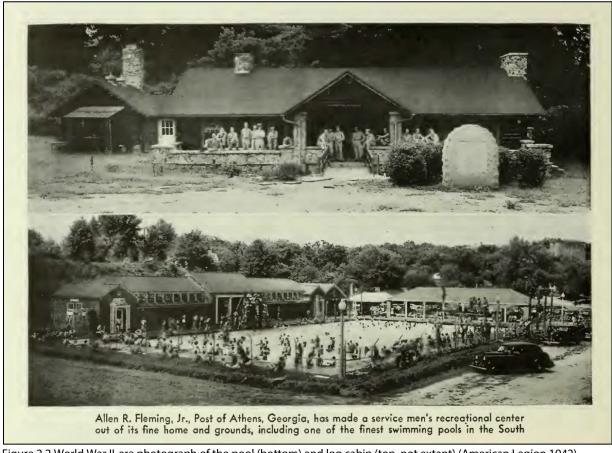
Figure 2.2 World War II-era photograph of the pool (bottom) and log cabin (top, not extant) (American Legion 1942).

The Legion also constructed a log cabin (see Figure 2.2) or meeting house to the east of the pool that could be used by both the Legion and other community organizations, such as the Boy Scouts. The cabin was completed by 1934 and officially dedicated in March 1935. The cabin, located on the north side of the present-day Legion Pool parking lot, was actually the first piece of the "community center," which included the pool, playground, and other amenities (*Athens Banner-Herald* March 31, 1935). Based on historic aerials, the cabin, later referred to as the "Legion Hut" (see Figure 2.4) was demolished c1960.

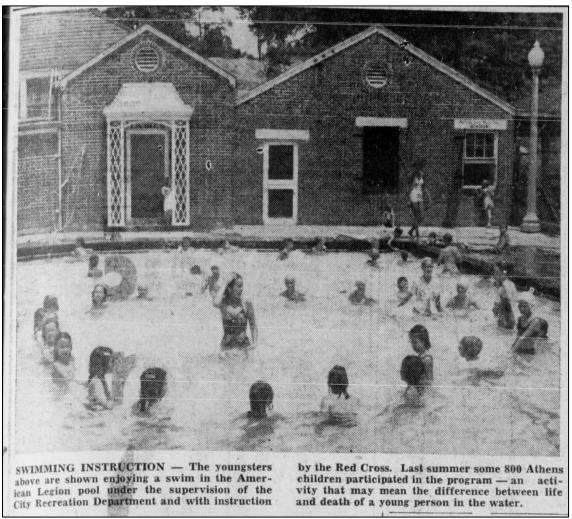
Figure 2.3 Swimmers at Legion Pool, 1949. This is the northern corner of the pool near the current concession stand (*Athens Banner-Herald* May 15, 1949).

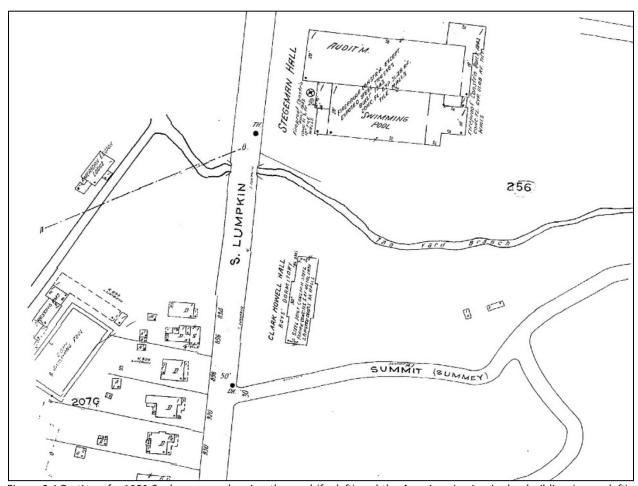
Figure 2.4 Portion of a 1950 Sanborn map showing the pool (far left) and the American Legion Lodge building (upper left). Copy of Sanborn map provided by the Athens-Clarke County Planning Department.

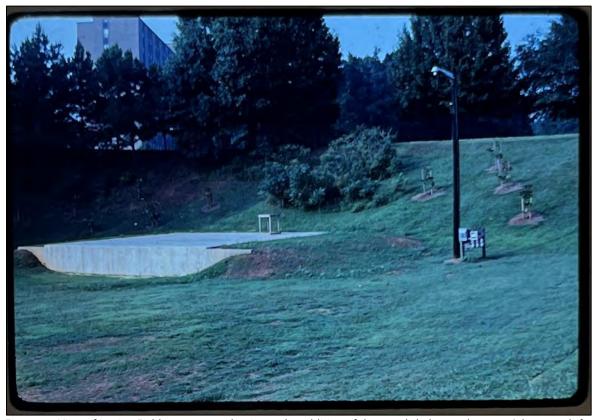
Figure 2.6 View of Legion Field concert stand, prior to the addition of the metal shelter, early 1980s (photograph from UGA Hargrett Library).

During the 1950s through 1980s, concurrent to the pool's continued use, adjacent Legion Field (Figures 2.5 through 2.8) also became a popular recreational area for UGA's student body, which arranged a host of events. During the 1950s, the recreational area appears to have been most popular for intramural sports events. However, beginning in the 1960s and through the 1980s, the field saw more widespread use and, with its surrounding grassed hillsides, provided a natural amphitheater atmosphere. Concerts, pep rallies, tailgate parties, class parties, and even poetry readings and children's television characters were scheduled at the grass field.

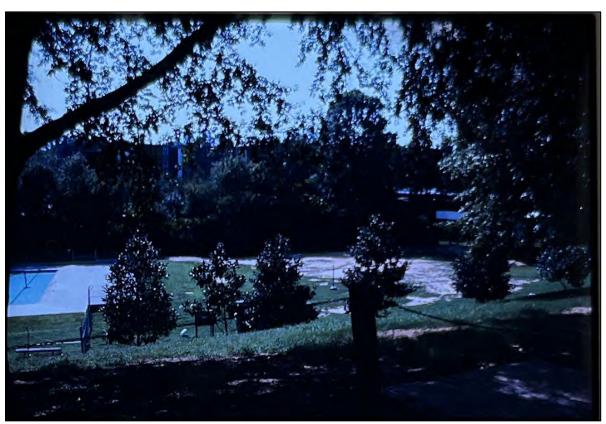
Figure 2.7 View of Legion Pool (left) and field (right), early 1980s. New concert stand shelter is visible at far right (photograph from UGA Hargrett Library).

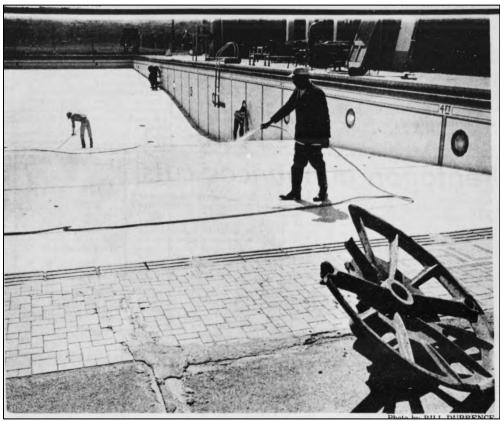
Figure 2.10 Cleaning of Legion Pool, 1973. Note original tile at pool ledge (Red and Black April 17, 1973).

By 1975, the City of Athens had opened another swimming pool at Bishop Park. With Legion Pool in need of upgrades and repairs, "[the City] was no longer interested in continuing to manage Legion." Until that time, because of the 1954 deed agreement UGA did not budget for its operation and, for the 1975 season, the Student Government Association "held an emergency referendum to allocate \$3,100" to support immediate repairs so the pool could open (Save Legion Pool 2025). The pool underwent major renovations in the late 1970s and early 1980s. This included significant repairs to the pool floor (patchwork repairs were superseded by a full replacement); all of the original tile lining the floor was removed and replaced with a marble-dust cement base bed. The original underwater lighting, composed of antique fixtures with irreplaceable parts, was also removed and replaced. Drainpipes were replaced and a new fence was installed around the pool's perimeter (*Red and Black* April 6, 1978; February 23, 1983). During this same period, the original tile around the pool deck was replaced, the pavilion materials were replaced, the shower stalls were modernized, and the bathhouse was modified to its current aesthetic (*Athens Observer* June 28, 1979). Figures 2.9 through 2.12 provide images of the pool during the 1970s.

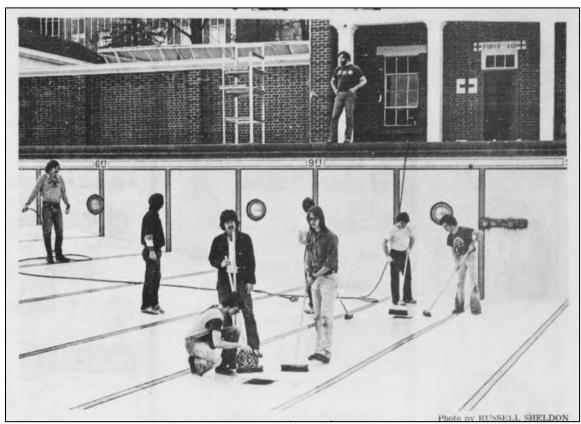
Figure 2.11 Readying Legion Pool for the season, 1977. Also showing original unpainted brick walls and windows of pool houser (*Red and Black* March 4, 1977).

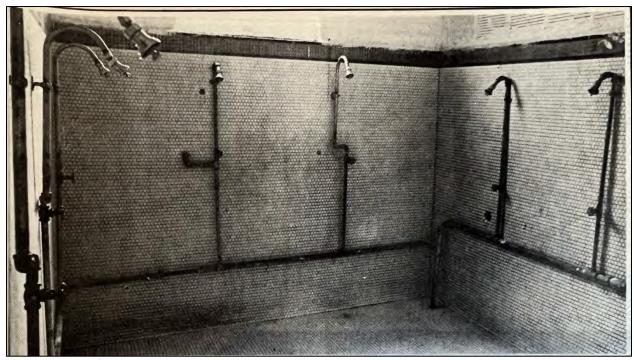
Figure 2.12 View of original showers in bathhouse (Athens Observer June 28, 1979).

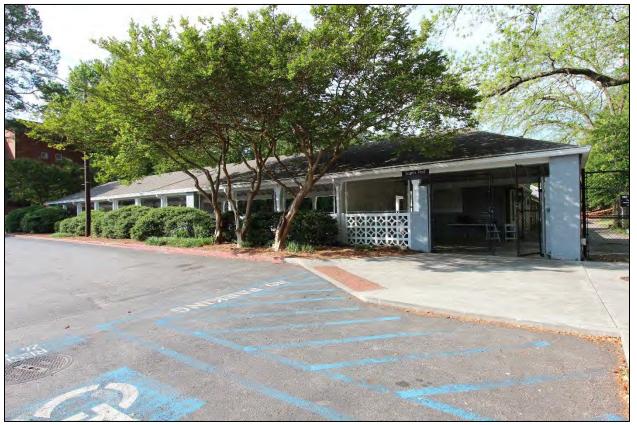
Figure 3.1 Pool House, near entry, facing south.

During this study, Brockington documented Legion Pool and its associated resources, all located at 802 South Lumpkin Street in the northern portion of the UGA campus in Athens. The facility, which includes Legion Pool (no number), the pool bathhouse (Building No. 2605), Legion Field (no number), and a non-historic concert stand (UGA Building No. 2638), is situated west of South Lumpkin Street between the Hill and Creswell residential halls (see Figures 1.1 through 1.8). The pool and bathhouse were constructed in 1935 and 1936 and the concert stand was constructed in 1983. The pool is oriented northeast-southwest, with the bathhouse forming an L-shape on the northwest and northeast sides of the pool. No original plans for Legion Pool or its bathhouse (Building No. 2605) were found, although the Hargrett Library does retain plans for the original 1930s filter system and its orientation within the basement level of the bathhouse. Figures 3.1 through 3.38 provide photographs of the complex.

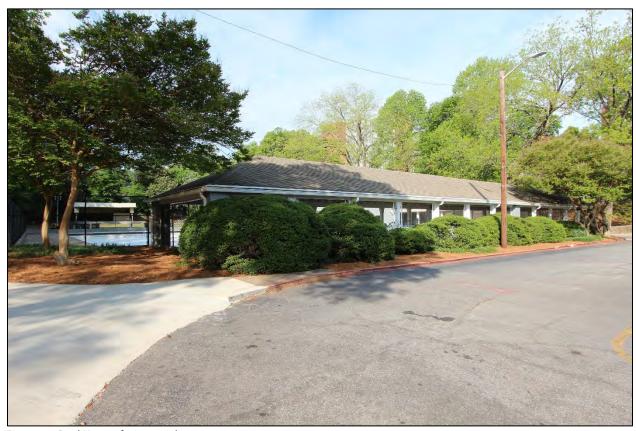
Figure 3.2 Pool House, facing southwest.

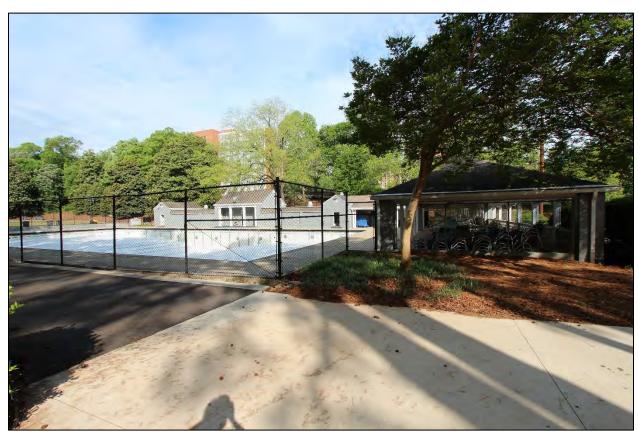
Figure 3.3 Pool House, facing west.

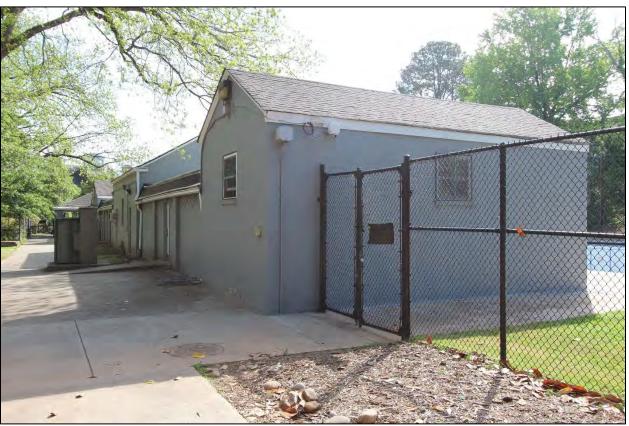
Figure 3.7 Pool House, ghost mark of old roofline, facing east.

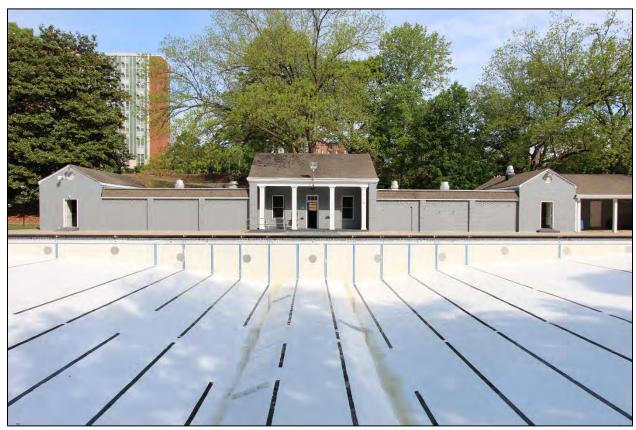
Figure 3.11 Pool House and pool (foreground), facing west.

Legion Pool (see Figures 3.11 through 3.15) measures approximately 150 feet in length by 75 feet wide. It ranges in depth from 2.5 feet at the opposite shallow ends to 9 feet at the center. It is largely lined with concrete, with the sections divided by inlaid black tile installed in the 1970s. The sides of the pool are concrete, though the upper walls are lined with 1-by-1-inch blue and white ceramic tile. The gutter and pool edge also feature black tile borders and the surrounding deck area is poured concrete. The majority of these construction materials date to the late 1970s renovations. Diving boards and stairs are modern, detachable, fiberglass units.

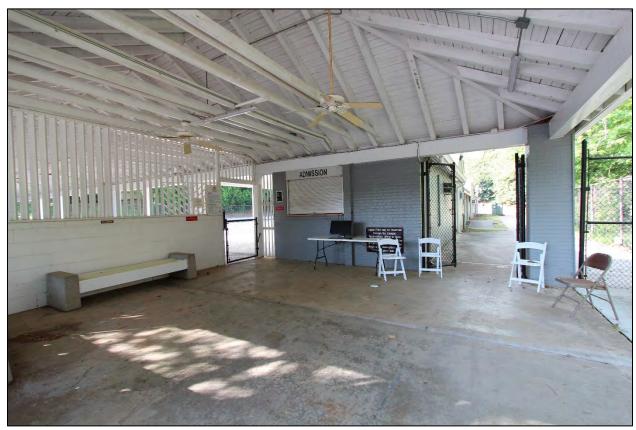
Figure 3.21 Pool House, pavilion area, facing southeast.

The pavilion (considered part of Building #2605; see Figures 3.21 through 3.23), located near the northeast end of the pool, is an open wood-framed structure with a wood trussed gabled roof clad in asphalt shingles. It measures approximately 125 feet long by 25 feet wide and is primarily supported with brick piers. The northeast side has additional wood supports set on a pierced concrete block wall, with those on the southwest side full height wood posts. The interior is open on all four sides, with the pool-side portion of the pavilion divided from the entrance area by a louvered upper wall. The pavilion is surrounded by decorative plantings and large crepe myrtles. Historic photographs (see Figure 2.2) suggest the pavilion and bathhouse were originally detached, with a covered access area between the two. However, based on historic aerials, the pavilion had taken its current connecting form by 1962.

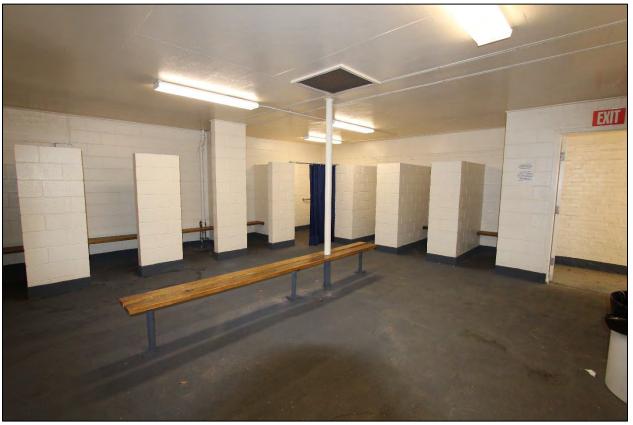
Figure 3.24 Pool House, southernmost wing, showing interior.

The c1936 bathhouse (Building #2605), located on the northwest side of the pool, includes space for gender-based bathrooms and showers, mechanical and storage areas, and other support spaces. Although its architectural design has been somewhat modified, it still features some of its original Colonial Revival style aesthetic, with brick walls, gable roofs, and brick detailing. Many of the doors are non-historic metal replacement units, with windows also being non-historic, two-over-two, double-hung sash replacements. The building consists of five distinct bays, with each end bay having a front-gabled functional space (currently used for storage of chemicals or other materials). The interiors of these two functional sections include terracotta block walls, although the southern wing has some remaining tile on its interior wall (see Figure 3.24).

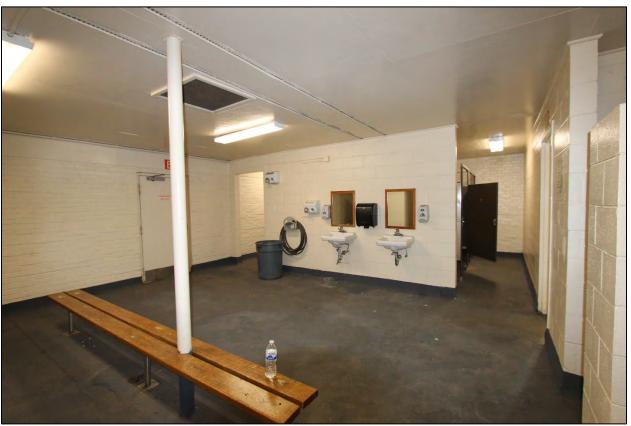
Figure 3.25 Pool House, women's changing area.

The next two bays toward the center include the men's and women's restrooms and shower areas (see Figures 3.25 and 3.26). These sections currently have a flat roof, but historic photographs show them originally with raised rooflines (see Figures 2.1 and 2.2) that were likely open and used for ventilation. Ghost marks of the original rooflines are visible on the gabled ends of the central portion of the building (see Figure 3.7). The exterior walls of the restroom areas also feature decorative brick detailing near the roofline. The interiors of the restrooms have been modernized (c1980) with new fixtures, benches, and tiled shower walls.

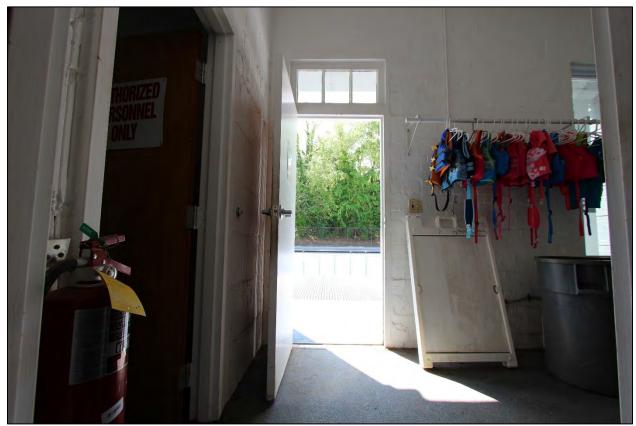
Figure 3.29 Pool House, central block, rear storage area, showing remnants of pressed metal ceiling.

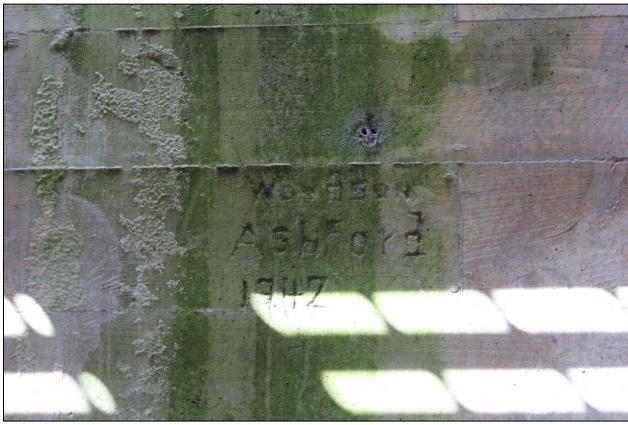
Figure 3.32 Pool House, basement, showing equipment, facing south.

The basement level (see Figures 3.32 and 3.33) features unadorned formed concrete floors, walls, and ceiling. All of the pool filtration equipment has been modernized, but portions of the original concrete stands for the filter tanks remain on the floor. One of the walls on the northeast side of the basement level includes the carved name of "Woodson Ashford, 1942." This appears to be George Woodson Ashford, born in Watkinsville, Georgia, in 1908. Ashford attended high school in Athens and briefly attended UGA before his acceptance into the U.S. Naval Academy in 1925. Ashford served in World War II, rising to the rank of Captain. He later served in the Korean War and died in 1981, having reached the rank of Rear Admiral

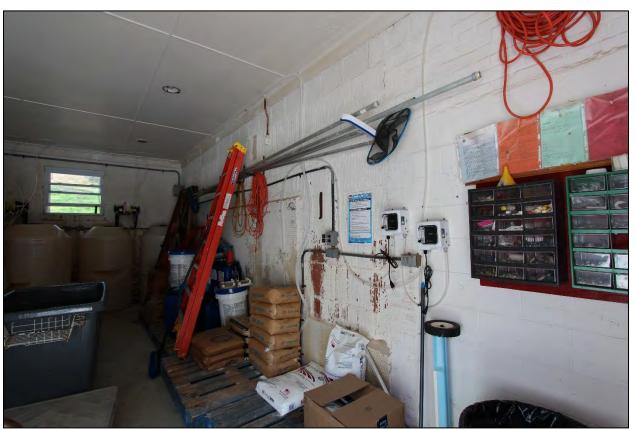
Figure 3.24 Pool House, southernmost wing, showing interior.

The c1936 bathhouse (Building #2605), located on the northwest side of the pool, includes space for gender-based bathrooms and showers, mechanical and storage areas, and other support spaces. Although its architectural design has been somewhat modified, it still features some of its original Colonial Revival style aesthetic, with brick walls, gable roofs, and brick detailing. Many of the doors are non-historic metal replacement units, with windows also being non-historic, two-over-two, double-hung sash replacements. The building consists of five distinct bays, with each end bay having a front-gabled functional space (currently used for storage of chemicals or other materials). The interiors of these two functional sections include terracotta block walls, although the southern wing has some remaining tile on its interior wall (see Figure 3.24).

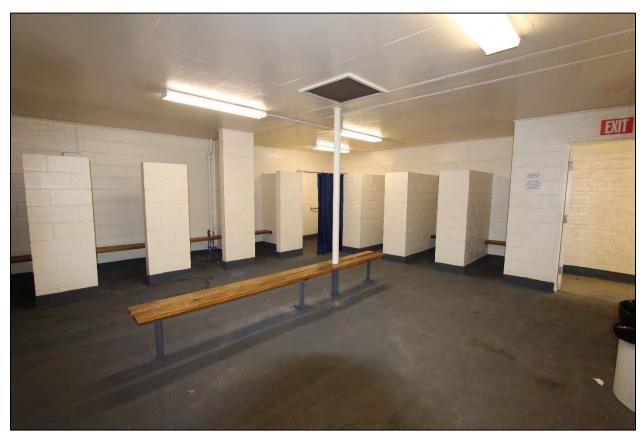
Figure 3.25 Pool House, women's changing area.

The next two bays toward the center include the men's and women's restrooms and shower areas (see Figures 3.25 and 3.26). These sections currently have a flat roof, but historic photographs show them originally with raised rooflines (see Figures 2.1 and 2.2) that were likely open and used for ventilation. Ghost marks of the original rooflines are visible on the gabled ends of the central portion of the building (see Figure 3.7). The exterior walls of the restroom areas also feature decorative brick detailing near the roofline. The interiors of the restrooms have been modernized (c1980) with new fixtures, benches, and tiled shower walls.

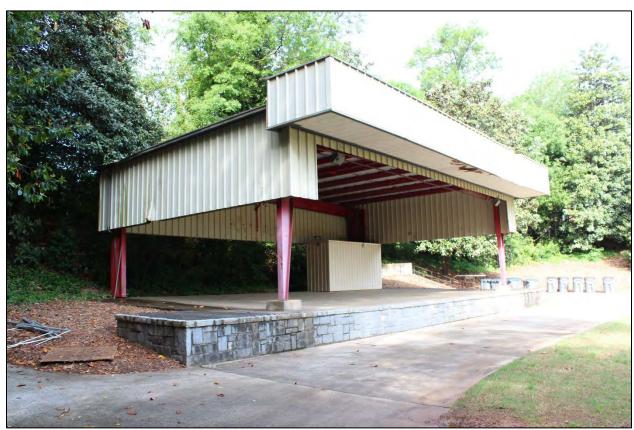
Figure 3.38 Legion Field, concert stand facing west.

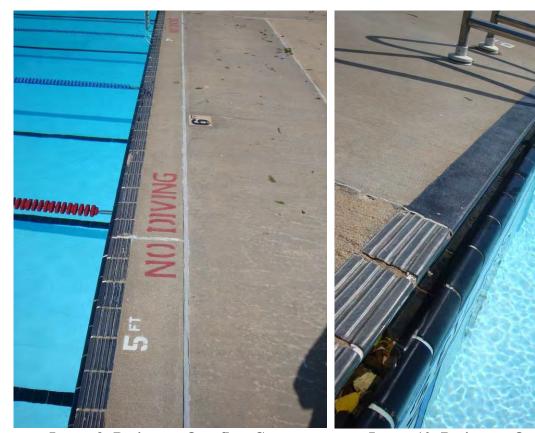
Image 9: Perimeter Overflow Gutter

- d) The pool perimeter gutter was originally designed to skim water off 100% of the pool's perimeter. This is also current best practice within the industry. With the two sides being out of level, this is not achievable. Once the condition of the subgrade is evaluated and remedied, it is recommended that the perimeter gutter be re-leveled to within 1/8" so that water is skimmed off the entire perimeter of the pool. Alternatively, the existing concrete and tile gutter could be removed and replaced with a stainless steel gutter.

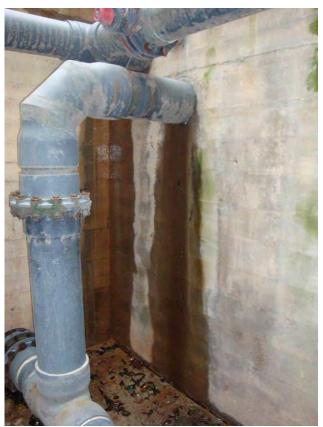
Image 39: Water Stains on the Walls

- d) The leaks at the coupler near the chemical injection point should be repaired. It's not known whether a water seal is provided around incoming and outgoing pipes in the mechanical room (see image #39). Water seals or link seals (even better) around those pipe penetrations should be considered, if practical.

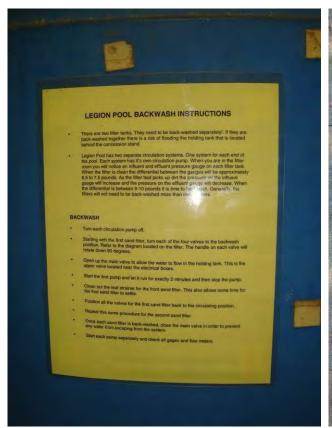
Image 63: Posted Backwash Procedure

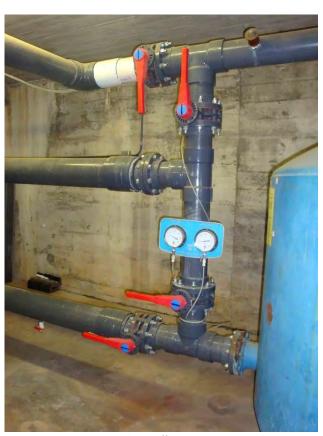
Image 71: Filter #2 Valve Manifold

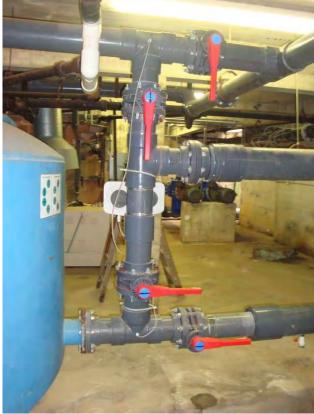
Image 72: Filter #1 Valve Manifold

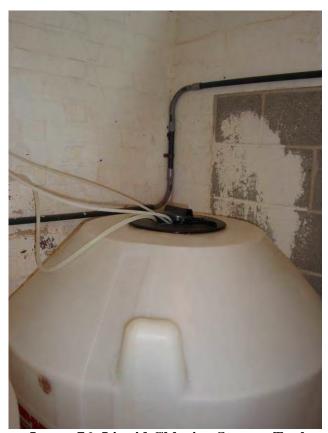
Image 76: Liquid Chlorine Storage Tank

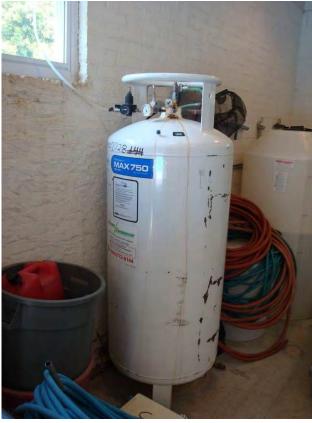
Image 77: 750 lb Carbon Dioxide Storage Tank

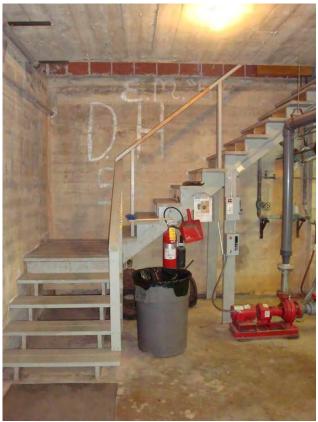
Image 93: Pool Mechanical Room Access

- a) If equipment removal / installation requires the removal of pool process plumbing, new piping that's required to be re-plumbed should be piped closer to the walls allowing for easier access in the future.
- b) Provide a water-based fire extinguisher in the pool mechanical room and chemical room in place of more common ABC-type extinguishers.

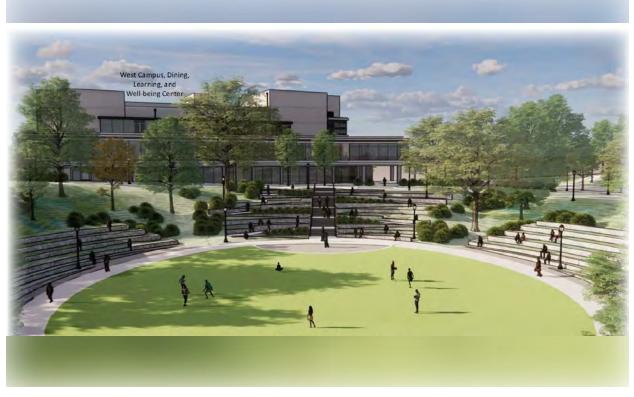
Concept view of a portion of Legion Field looking south with the existing fence and stage removed, new security lighting, amphitheater elements, and pathway connections to the new West Campus Dining, Learning, and Wellbeing Center (which is under construction and opening Fall 2026).

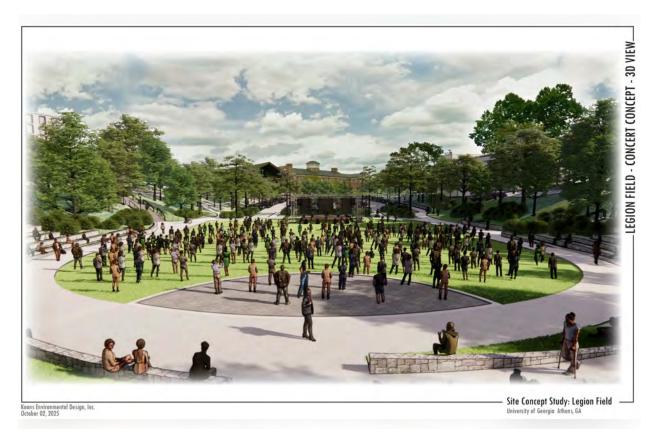
Concept view of the redeveloped Legion Pool and Legion Field area looking north with new security lighting, amphitheater elements, and pathway connections.

Eric Atkinson: We're very excited about how this project will enhance the living-learning experience of our students. As part of the redevelopment, Legion Pool, its pool house, and the existing concert stand will be removed, and Legion Field will be significantly expanded to create a beautiful and functional community green space. The project also includes a new outdoor amphitheater that will take advantage of the site's natural topography, creating a versatile venue for concerts, programs, and events.

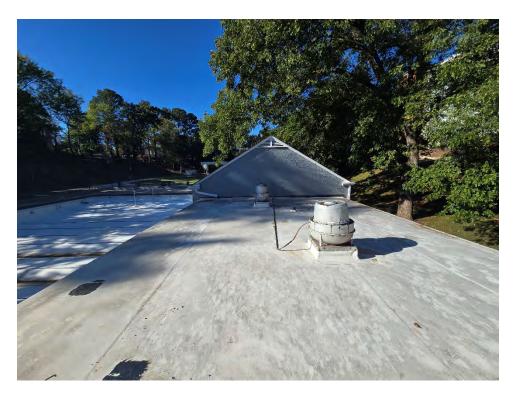
3. ACM asphalt built-up (BUR) roof under TPO on Pool House (Flat Roof 1)

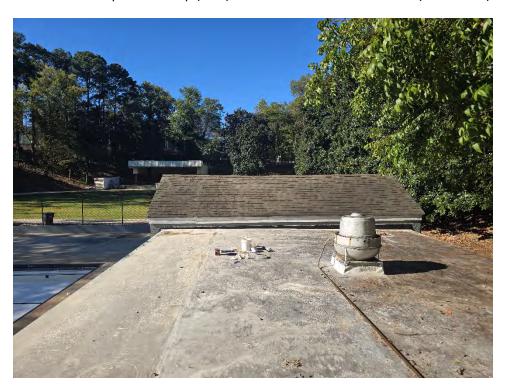
4. ACM BUR under TPO on Pool House (Flat Roof 2)

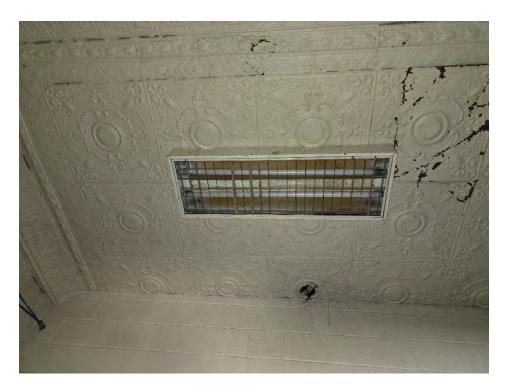
5. Typical fluorescent mercury-containing bulbs inside Pool House & suspect PCBs lamp ballast in Storage Room 10

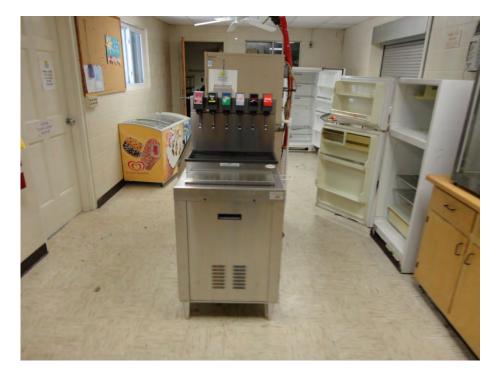
1. ACM black mastic under 12x12 inch floor tile in Room 1 Concessions (former gameroom).

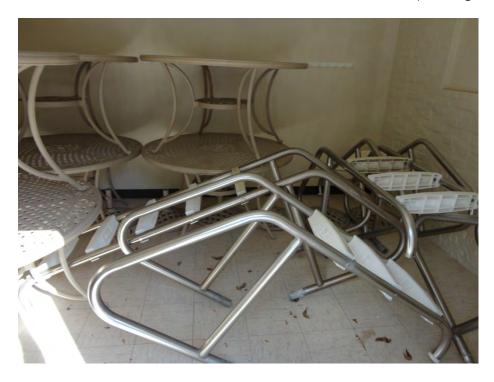
2. ACM black mastic under 12x12 inch floor tile in Storage Room 2 (former snack sales).

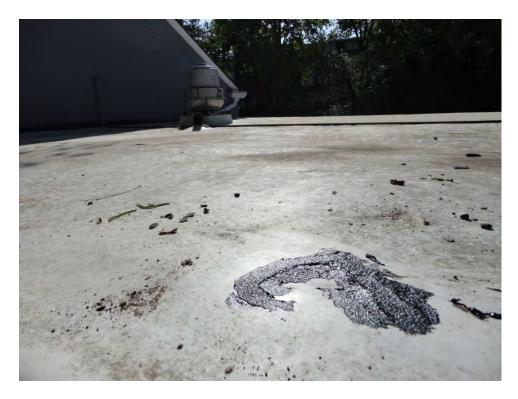
3. ACM built-up asphalt roof atop enclosed concessions/bathhouse structure.

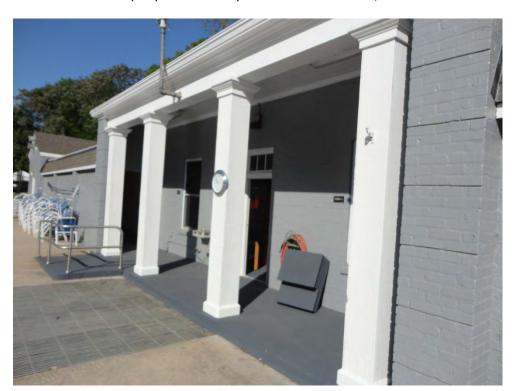
4. LBP in exterior white support columns in main structure.

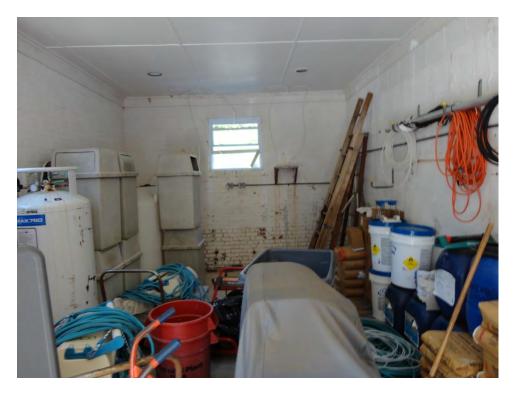
5. LBP in interior white brick walls in Storage Room 15.

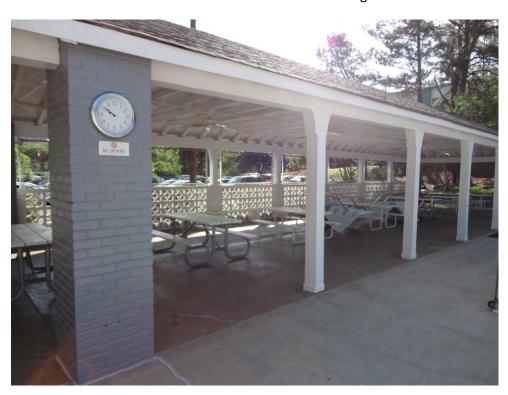
6. LBP in white support columns and ceiling in shade pavilion.

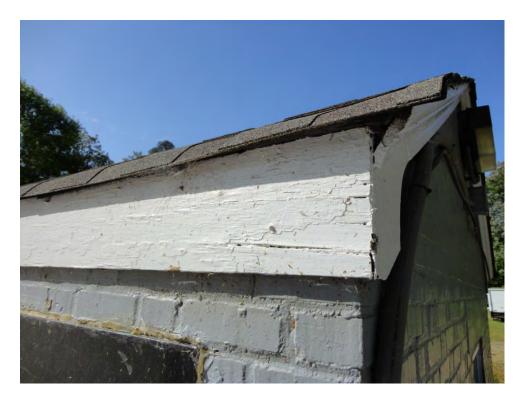
7. LBP in exterior white fascia board in main enclosed structure.

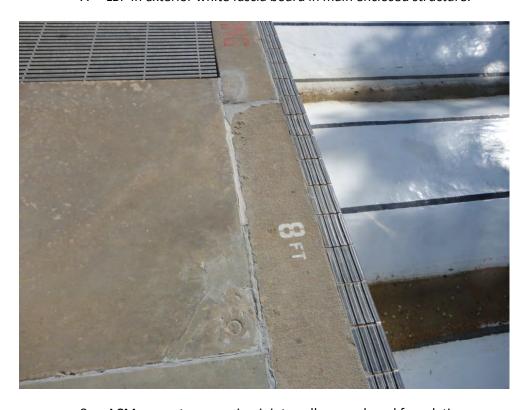
8. ACM concrete expansion joint caulk around pool foundation.

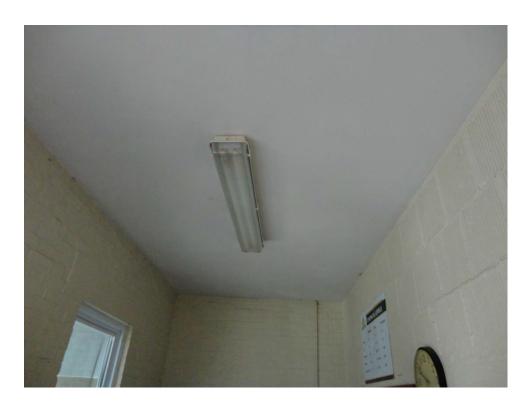
9. Typical mercury-containing fluorescent light bulbs in enclosed bathhouse structure.

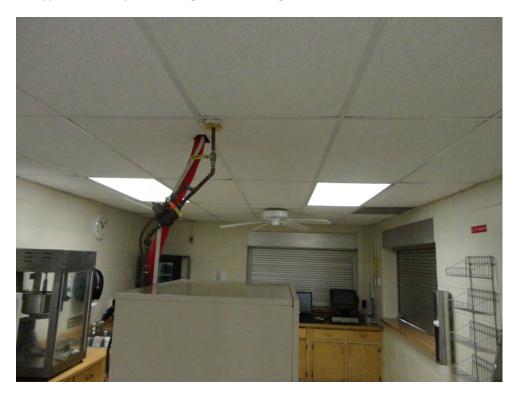
10. Typical mercury-containing fluorescent light bulbs in Concession room.
